8.0 Gunnison, Colorado, Disposal Site

The Gunnison, Colorado, Uranium Mill Tailings Radiation Control Act (UMTRCA) Title I Disposal Site, was inspected on June 3, 2008. The disposal cell and all associated surface water diversion and drainage structures were in excellent condition and functioning as designed. Six riprap test areas on the cell apron and diversion ditches were visually inspected; no apparent rock degradation was noted when compared to previous photos. A deep-rooted shrub was removed from the top of the disposal cell. The perimeter fence was repaired at several locations from damage caused by significant snow accumulations during the winter. Several damaged and missing perimeter signs were replaced. Snowmelt runoff resulted in minor erosion near the southeast corner of the site; repair is not warranted at this time. No other maintenance needs or cause for a follow-up or contingency inspection was identified.

Figure 8-1. 2008 Annual Compliance Drawing for the Gunnison Disposal Site

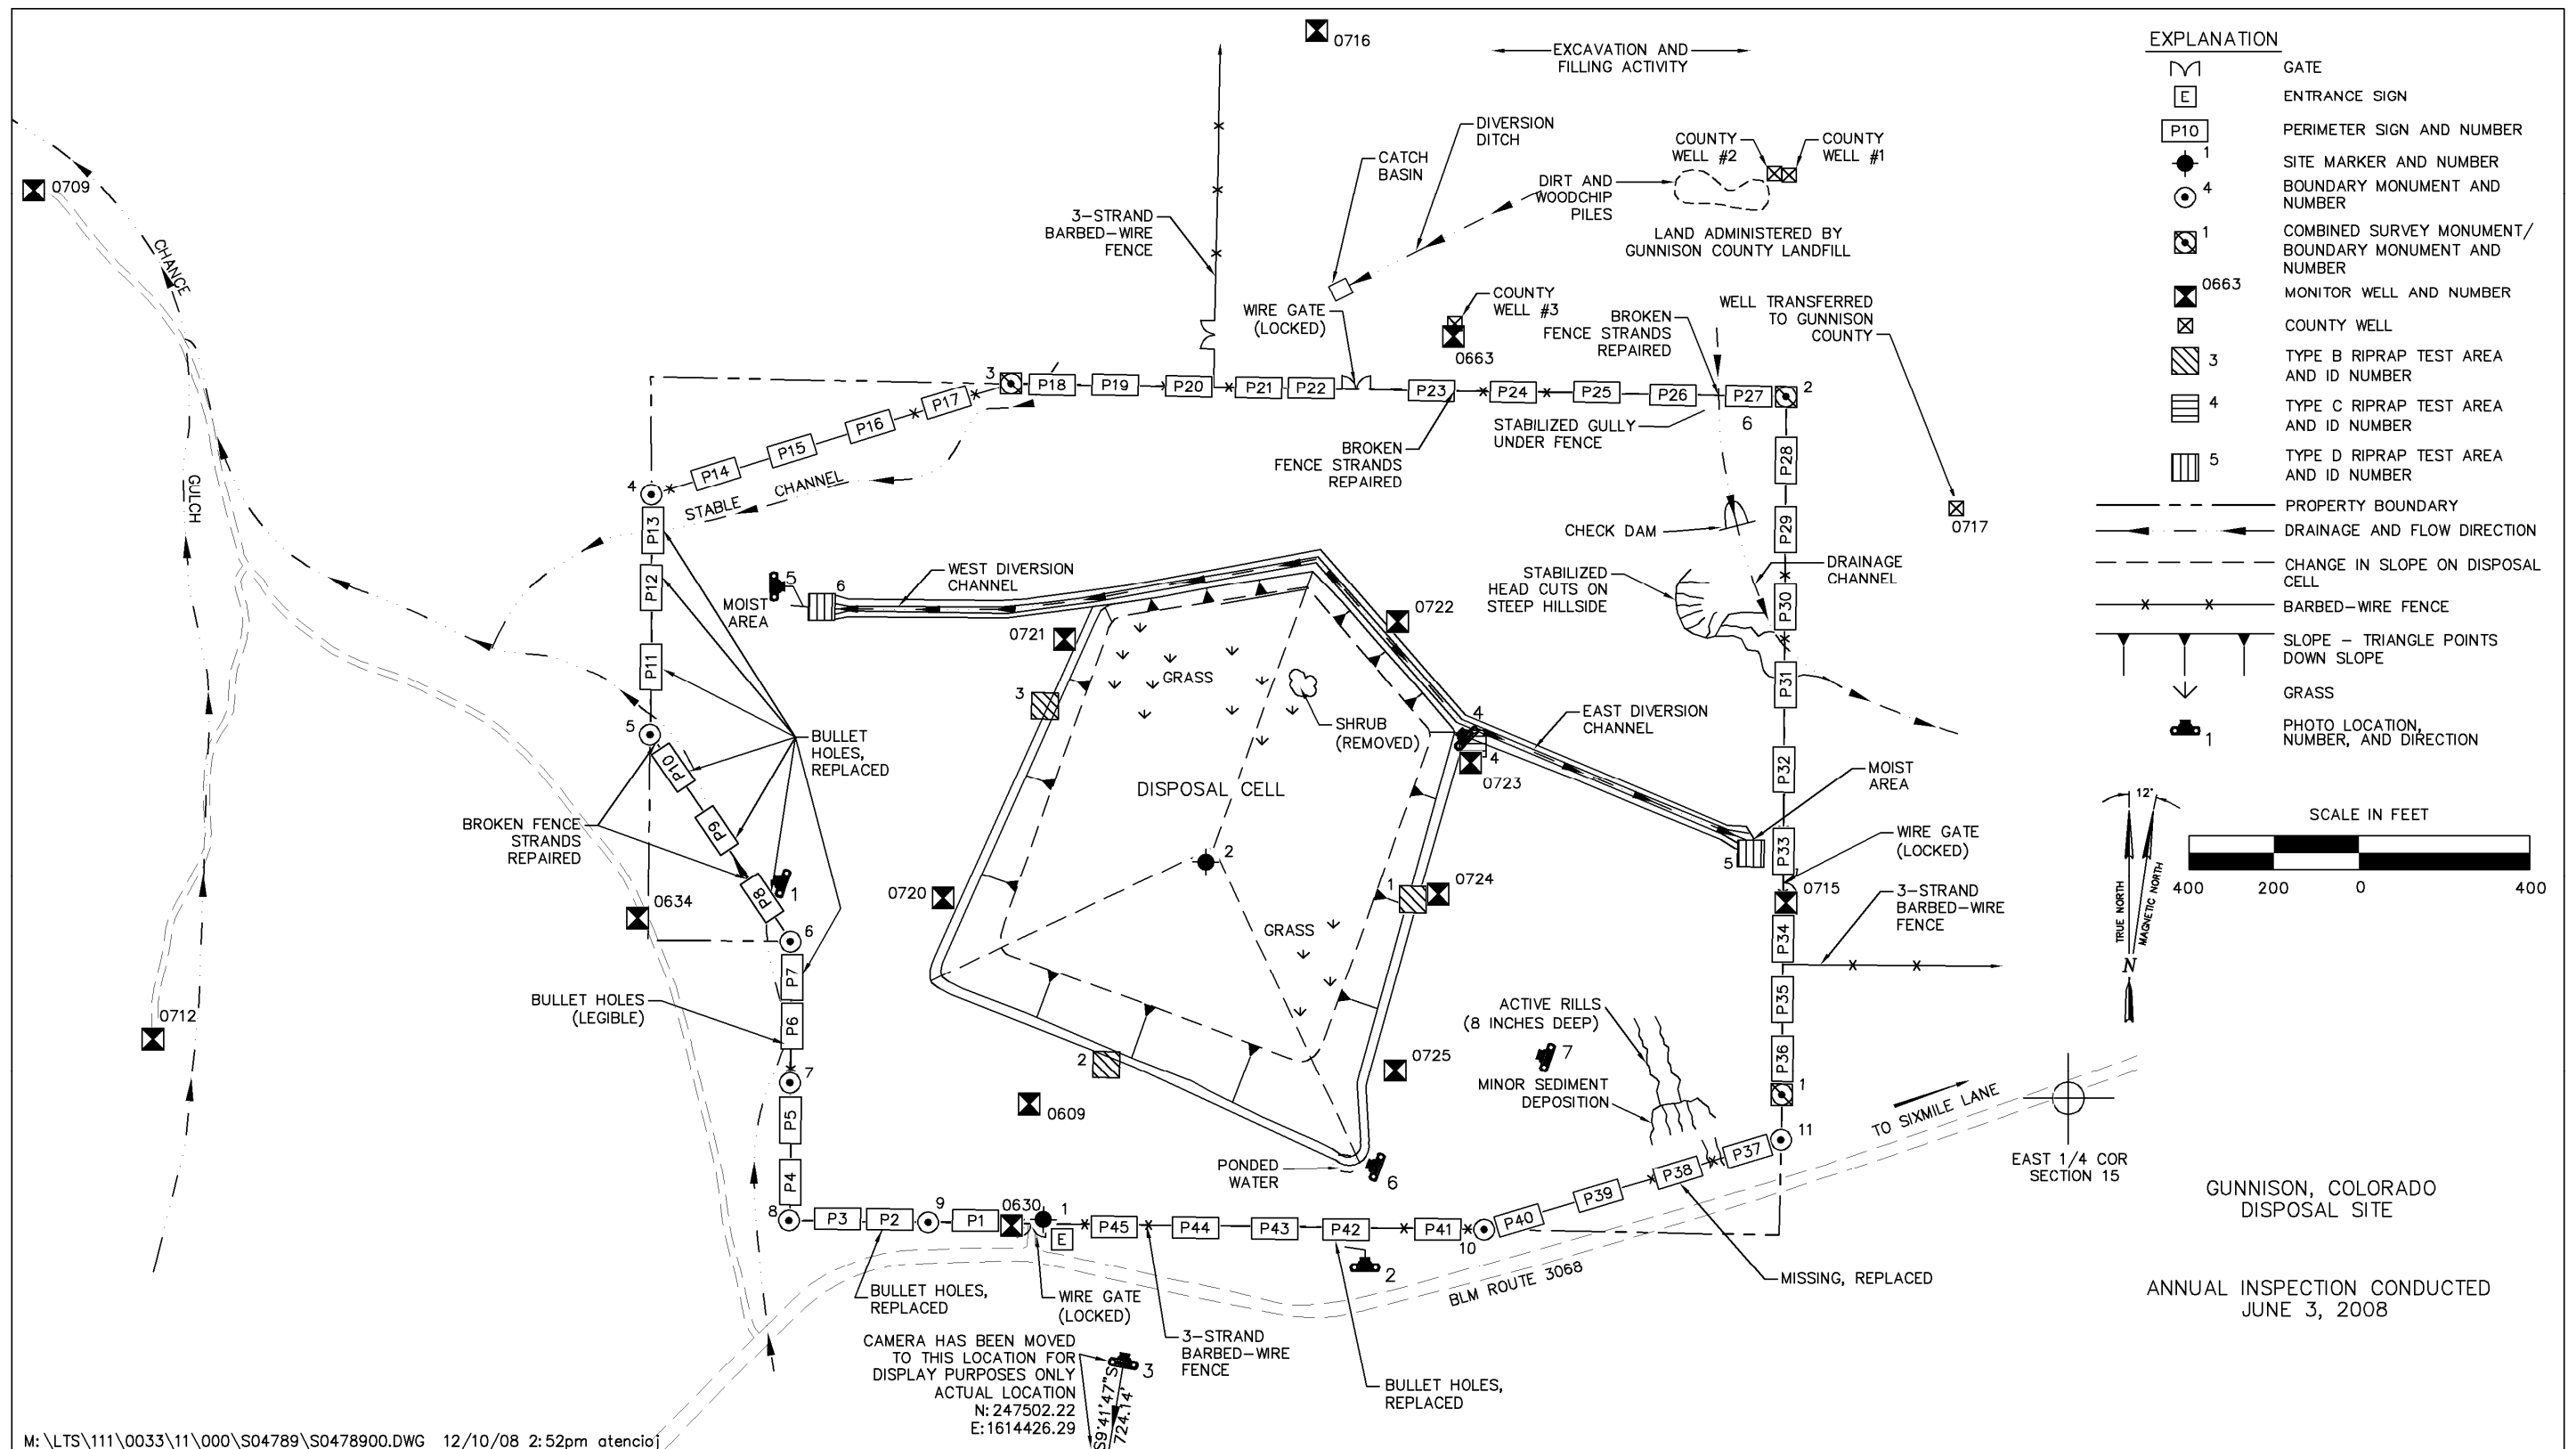
8A A three-strand, barbed-wire fence delineates the site; most of it is set along the property boundary. Fence strands were broken at several locations along the north and west sides of the site (PL–1). This damage is attributed to the above-average snow accumulation that occurred during the past winter. The broken strands were repaired on June 19, 2008.

8B The entrance sign, located at the south entrance gate, is in good condition. Forty-five perimeter signs are bolted to the perimeter fence posts. Nine perimeter signs (P2, P7, P8, P9, P10, P11, P12, P13, and P42) were heavily damaged by bullets (PL–2), and one perimeter sign (P38) was missing; new signs were installed at these locations on June 19, 2008. The remaining signs were in good condition.

8C **Top of Disposal Cell**—The top of the disposal cell was in excellent condition. There was no evidence of erosion, settling, slumping, or rock degradation (PL-3). Several isolated patches of grass were randomly distributed over the disposal cell cover; however, these shallow-rooted plants are not a cause for concern. One small deep-rooted shrub was found on the cell top and was cut and treated with herbicide in accordance with the LTSP. Many small indentations continue to be present on the cell cover. The indentations, with dimensions up to 4 inches across and up to 4 inches deep, appear to have been caused by pronghorn antelope. None of the indentations penetrate into the bedding layer under the rock cover, and they are not a cause for concern.
